Manhole Inspection Summary

Manhole # S35UU_003MH

Insp Date: 1/11/07 12:56 PM

Location Address: **345 28TH ST**

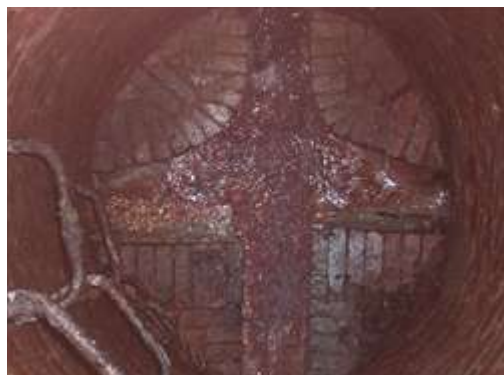
Top View

Corroded steps. Bench debris.

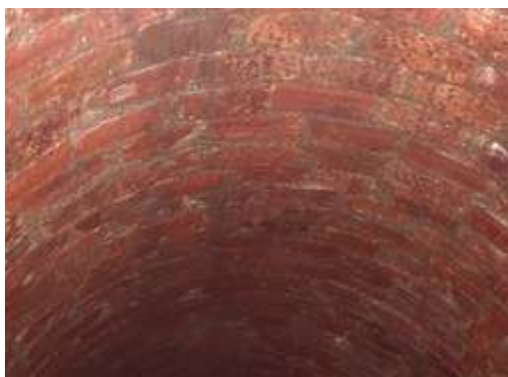
Defect

Infiltration: ☐ None ☒ **Joint** ☐ Cracks ☐ Mortar ☐ Roots ☒ **Wall**

Adjustment infiltration.

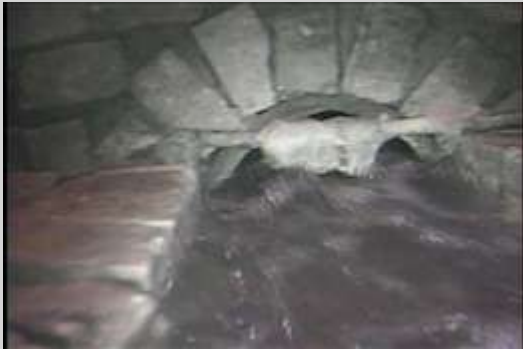
10 in. Circular Gravity Sewer Pipe Out @ 12 O'Clock

Deposits: ☐ None ☒ **Mud** ☐ Sludge ☒ **Debris** ☒ **Grease**

Silt Depth: **3** (in.) Deposits Extent: **Medium**

Infiltration: **Evidence** Pipe Seal Cond: **Unknown**

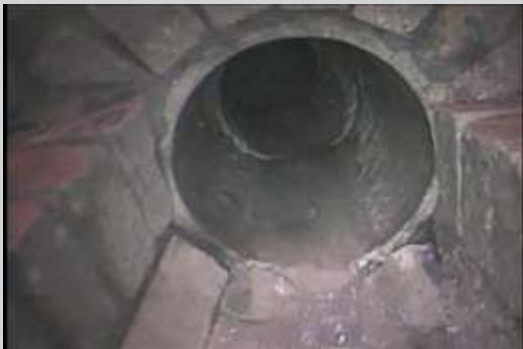
8 in. Circular Gravity Sewer Pipe In @ 3 O'Clock

Infiltration: **Evidence** Pipe Seal Cond: **Unknown**

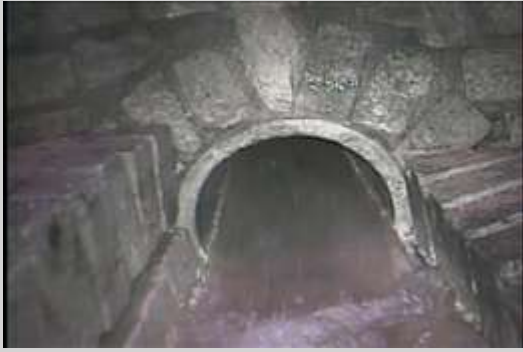
Pipe In @ 6 O'Clock

Channel deterioration.

Deposits: ☐ None ☐ Mud ☐ Sludge ☒ Debris ☒ Grease

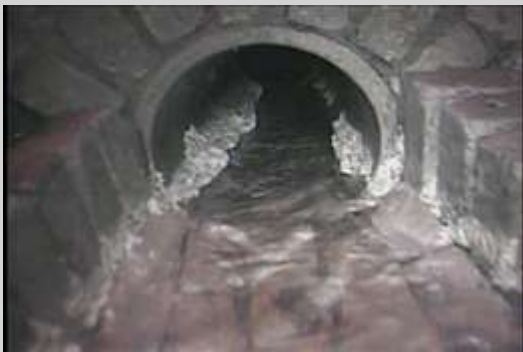
Pipe In @ 9 O'Clock

Grease depsoits.

Deposits: ☐ None ☐ Mud ☐ Sludge ☐ Debris ☒ Grease
